## Devil's Slide/Hwy 1 Storm Repair

Daily Updates from Bijan Sartipi

**Daily Update**  
July 13

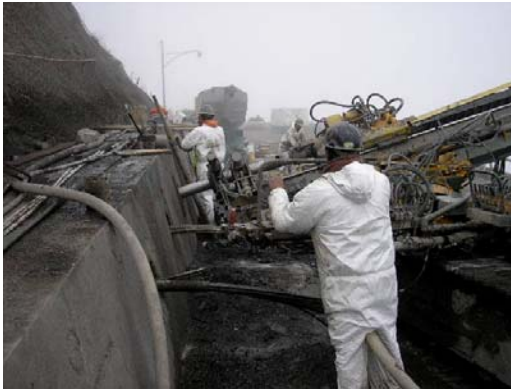
- Level 'B' (lower level ocean side) – Drilling for tie backs was completed today. 58 of 58 tie backs now installed. Tie back stressing continued.
- Level 'D' (upper level cliff side) – Drilling for tie backs continued today from the bench. 29 of 33 now installed. Cable stressing started today.

Drilling at level D

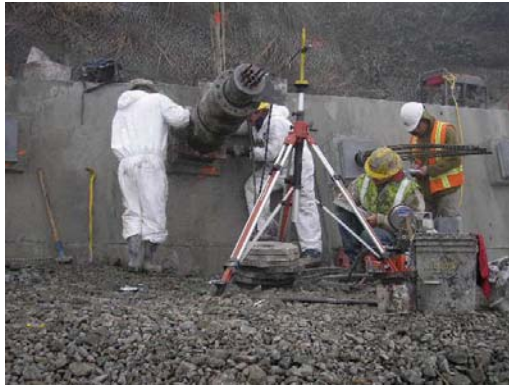
Cable stressing – level D

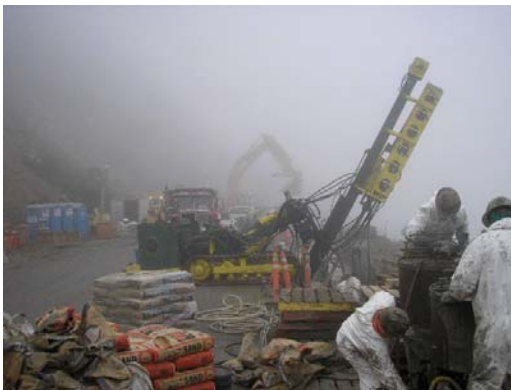
- Drilling and driving steel piles continued today. 45 of 99 now installed.

Micropile drilling

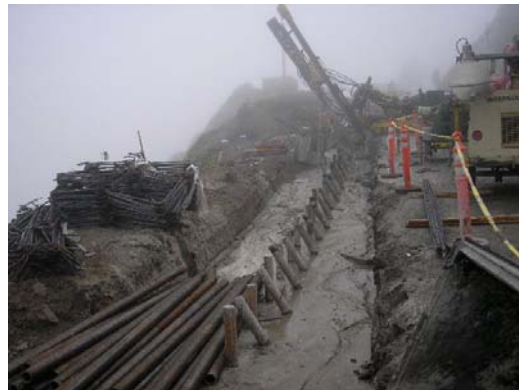
View of installed micropiles.
